**MOHAWK RIVER BASIN**

**LOCK 4 EMBANKMENT  
WATERFORD FLIGHT DAM**

**INVENTORY No. NY 968**

**PHASE I INSPECTION REPORT<sup>E</sup>  
NATIONAL DAM SAFETY PROGRAM**

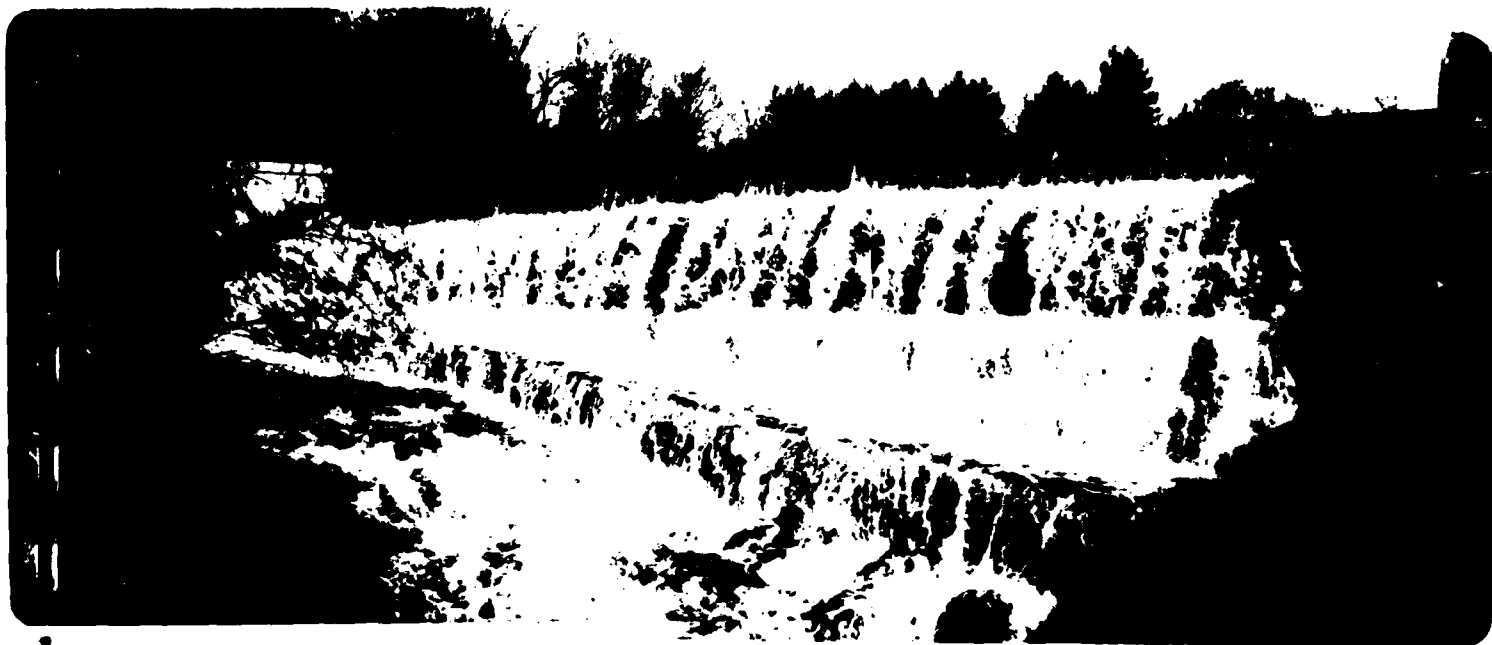
The spillway has a stepped downstream face. Rock is exposed in the downstream channel immediately below the spillway and it appears that the spillway structure bears on rock. Flow was occurring over this spillway at the time of the inspection and the condition of the concrete in this structure could not be accurately evaluated. The spillway appears to be stable with no indications of misalignment or other structural movements, nor significant loss of section noted. The spillway abutments similarly appear structurally stable, although some deterioration of the surface concrete has occurred near the water line.

5. Spillway located at the end of right embankment.

Further investigation is recommended for the spillway structure, with the thought that methods to improve the stability of the spillway will have to be developed. Because of the influence on structural stability, additional studies should include evaluation of uplift pressures which act upon the base of the spillway. The engineering properties of the foundation rock should also be determined, in order to analyze resistance to displacement and obtain data relative to providing an anchorage system for the spillway section.
